Effect analysis of an arc-strike-induced defect on the failure of a post-tensioned threadbar

A temporary threadbar used for precast segmental construction broke during the post-tensioning stage before reaching the service load. Failure analysis showed that the premature failure of the bar was due to the presence of an arc strike. The arc strike effects on the material and threadbar integrity are considered.

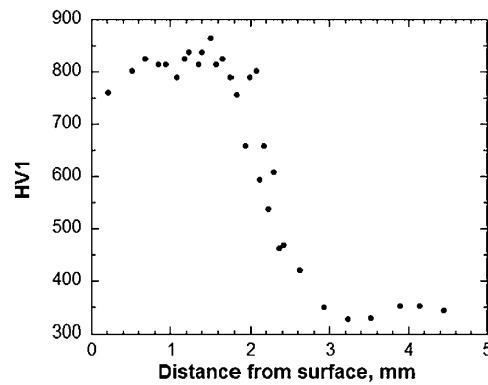
Fig. 6. Variation of the Vickers hardness (9.8 N) with distance from the bar surface in the AS affected zone.

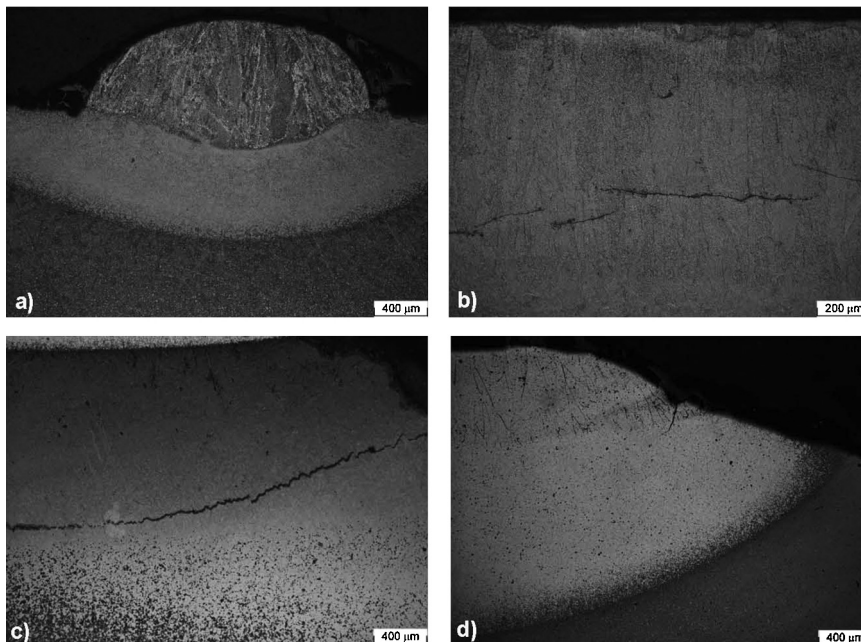
The AS longitudinal and transverse cross sections were prepared metallographically to evaluate the AS-induced damage. Fig. 7 shows representative AS-induced defects found in the bars. Only in one AS were no defects observed (Fig. 7(a)). In other cases, cracks at the molten metal parallel to the bar axis (Fig. 7(b)), at the heat-affected zone bordering the molten metal (Fig. 7(c)) or a small surface crack emerging at the toe of the molten metal and contouring it (Fig. 7(d)) were found. Because of

the cracking runs parallel to the contour of the solidified molten metal (Fig. 7), the possible damage to the threadbar is limited to the AS-affected material spalling. These defects are similar to those referred to in welding as “cold cracking” [10].

Fig. 7. Optical micrographs showing the representative details found in the bars of the AS-induced damage. (a) No macroscopic AS-induced damage. (b) Crack at the molten metal parallel to the bar axis. (c) Crack at the heat affected zone bordering the molten metal. (d) Surface crack at the toe of the molten metal.

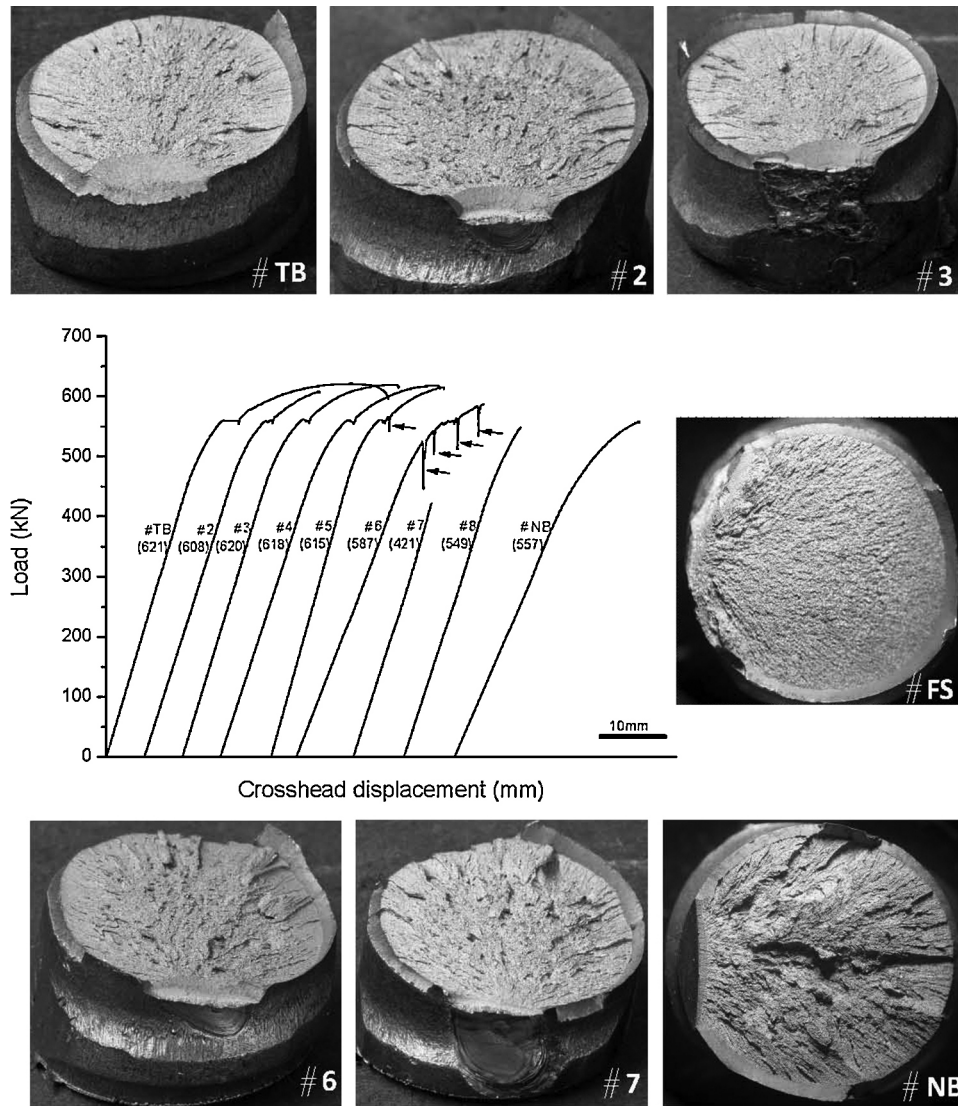
Fig. 8. Load-displacement curves for the undamaged (test #TB), AS-affected (tests #2 to #8), and notched (test #NB) bars, and macrofractographs showing the appearance of the fracture surface of the samples. Additionally, for comparative purposes, the fracture appearance of the broken during service threadbar is shown. The black arrows indicate a pop in. The numbers in brackets are the rupture load values.

Tensile samples of the AS-affected threadbar were tested at the same conditions as the abovementioned undamaged sample. Fig. 8 shows the AS effect on the tensile behavior and the corresponding fracture appearance. For comparative purposes, the following information was included in the figure: the test curve of an undamaged threadbar (TB), the test curve of a threadbar with a transverse arc-shaped notch with a 100 mm curvature radius, 0.25 mm thickness and 1.95 mm depth (NB); and the fracture appearance of the bar that was broken during service (FS). The first conclusion one draws from this figure is the wide tensile behavior variation of the AS-affected threadbar. It is remarkable that for some samples (#2, #3, #4, and #5) the AS did not affect the yield load. Whereas for others (#3 and #4), the AS did not affect the yield load or the ultimate load. However, the location of the rupture is AS-determined. In test #5, a local brittle fracture (pop-in) was noted during tensile testing, but the material fracture toughness was sufficient to stop the crack and allow further plastic deformation to reach the final brittle fracture condition. In test #6, four pop-ins took place prior to reaching the final brittle fracture condition. Test #7 was the only test in which the sample broke in the elastic region of the load-elongation curve prior to reaching the service load of 0.7 times the ultimate load. Moreover, the fractographic features of the fracture surface of the sample are very similar to that of the fractured bar in service. It is worth mentioning that except for test #7, in the remaining tests, some ductile crack extension prior to the final brittle fracture was produced. In tests #8 and #NB, the final brittle fracture took place at approximately the yield load. It is clear that the AS-induced defect severity can be higher than in the notched sample.
